*Living Shoreline Sea Level Resiliency:
Performance and Adaptive
Management of Existing
Breakwater Sites*

Living Shoreline Sea-Level Resiliency: Performance and Adaptive Management of Existing Breakwater Sites

Year 2 Summary Report

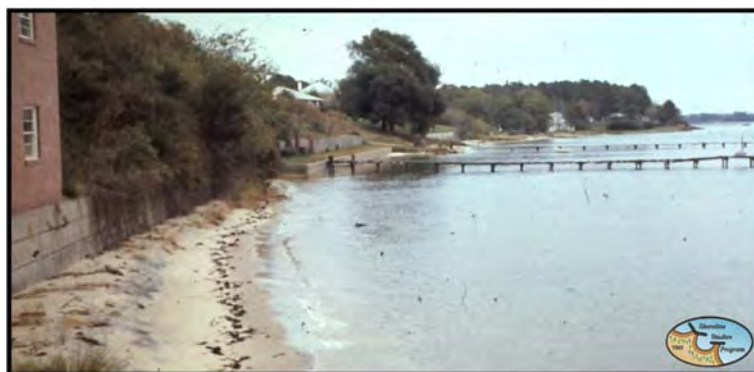
Figure 4-1-4. Very little sand existed along the VIMS shoreline in 1970.

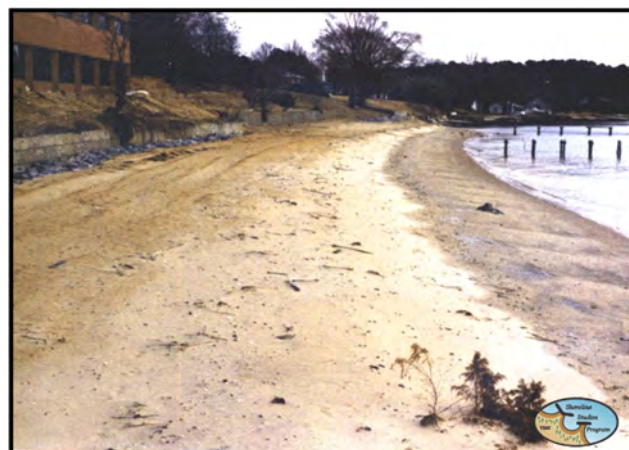
Figure 4-1-6. A revetment was installed and covered with beach fill along the shoreline to provide protection to the seawall.

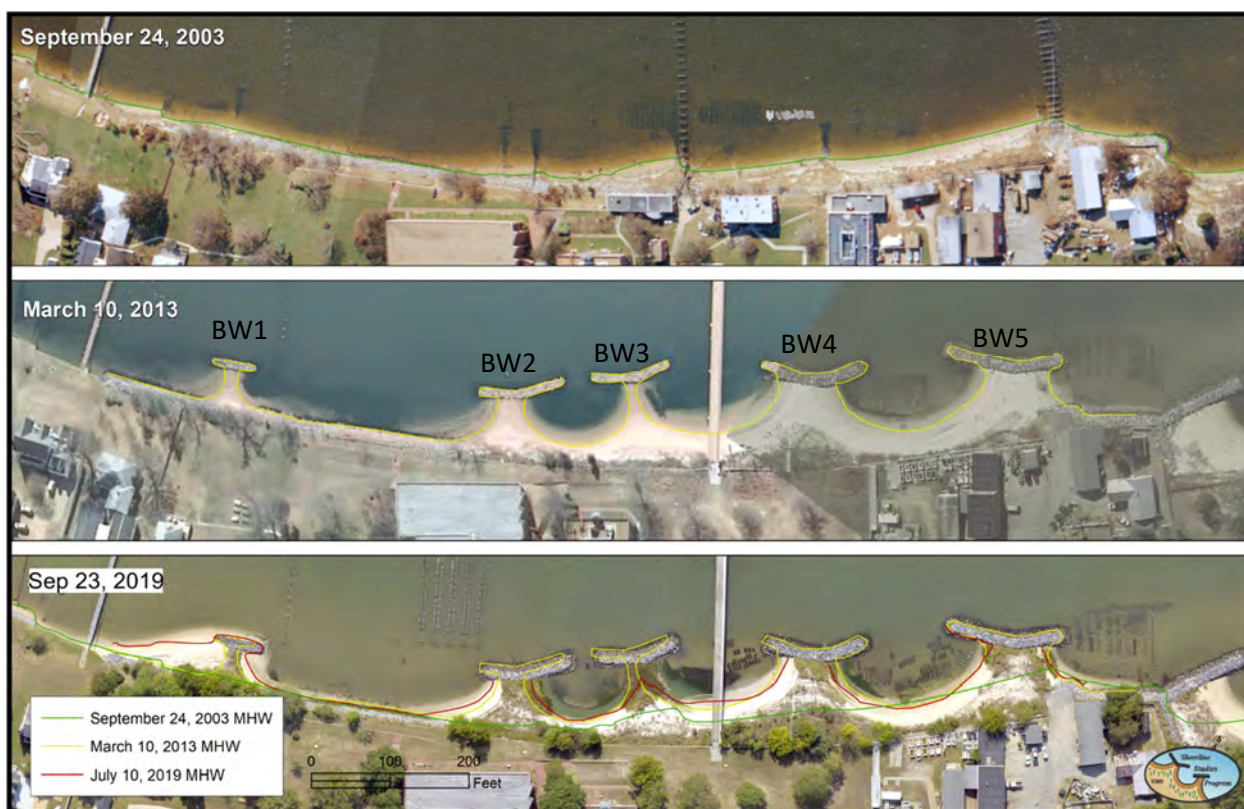
updrift breakwater because sand movement along this section of shoreline is to the south. In addition, SAV has established itself in the embayments. It should be noted that the 2013 and 2019 MHW shorelines in the embayment between breakwater 4 and 5 are slightly landward of the 2003 post-Hurricane Isabel high water shoreline. Positioning of the structures and sand fill had to accommodate the established biological experiments located in the nearshore. As such, the gap between the structures was placed such that the minimal amount of fill would be placed near these experiments. This has not impacted the effectiveness of the system because the embayment is still wide enough that vegetation grows in the backshore to help hold the sand and should an extreme event occur, the embayment is backed by the seawall. The highest areas are along the backshore next to the seawall (Figure 4-1-11). Though the tombolo right adjacent to the pier is vegetated, it still does not have as much sand behind the structure as the other breakwaters.

Figure 4-1-10. Shoreline change between 2003 and 2019 at the VIMS breakwaters. The 2003 pre-installation date is shown for reference. The 2003 and 2013 shorelines are approximately mean high water based on the digitizer's best guess of the features shown. The 2019 shoreline is from the survey data.

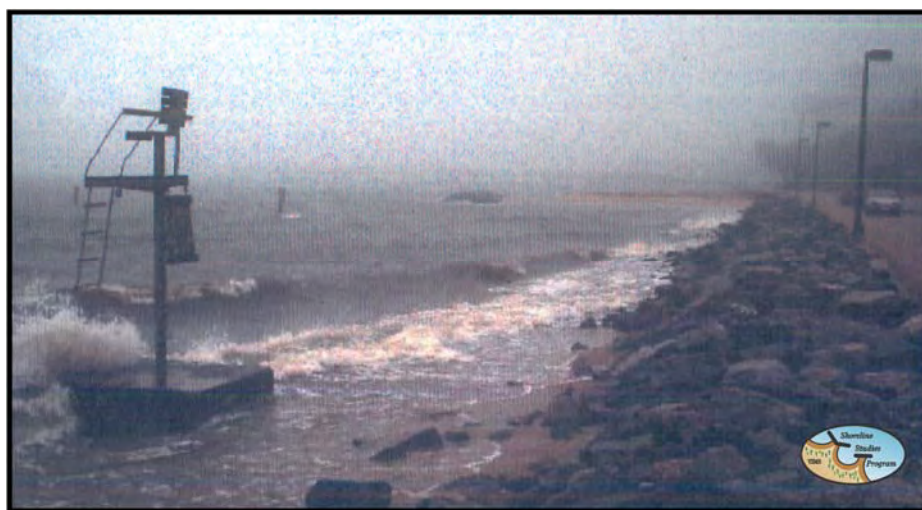
The history of the site, design guidelines, and performance of the Yorktown site over time has been documented in Milligan *et al.* (1996, 2005, & 2006), but a general summary is presented here. In 1978, York County installed a riprap revetment along its picnic area shore to the east end of Yorktown. This area had been filled in Colonial days to expand the warehousing facilities at the Port of Yorktown. After a damaging storm in November 1985, a small breakwater with beach nourishment was installed in order to maintain a storm water outfall. Subsequent renourishment occurred three years later, but the northeast storm in March 1993 severely eroded the shoreline (Figure 4-2-2).

Figure 4-2-2. Yorktown Beach shoreline on 4 March 1993 during a northeast storm.

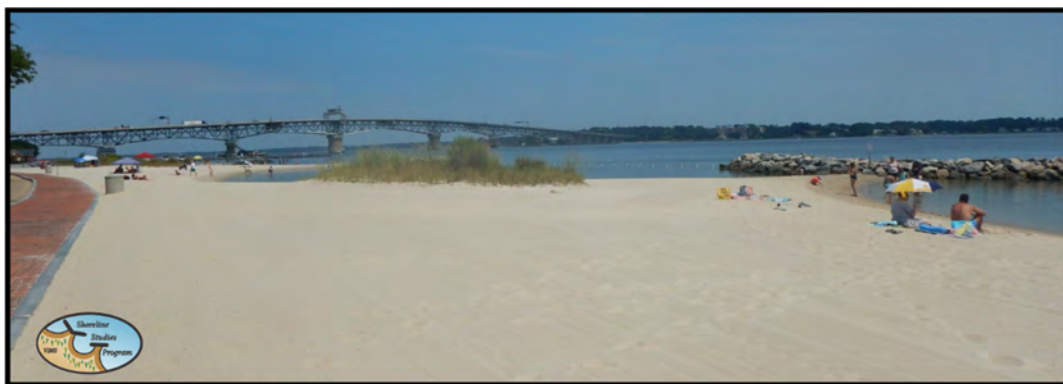
Today, the beach is wide and heavily used for recreation (Figure 4-2-4). The MHW shoreline is farther riverward than it was in 2004 and 2013 (Figure 4-2-5). This wide beach provides protection for infrastructure in the backshore because during high water events, the waves will break on the breakwaters or the beach before they cause damage. Highest elevations are located along the backshore and in the middle of the tombolos where the vegetation occurs (Figure 4-2-6).

Figure 4-2-4. A wide recreational beach exists at Yorktown Beach shoreline on 31 Jul 2019. Though the backshore is low, the beach provides protection to upland structures.

At Yorktown, in addition to raising the backshore barrier, to address the 1 and 2 foot SLR by 2050, an increase in breakwater height is recommended (Figure 5-2). The new armor should be at least 2-3 feet higher to accommodate the required rock size which is 1 to 2-ton armor. Perhaps a more reasonable approach to raising breakwaters is to add rock blocks/rectangles along the crest. As an example, these would be on the order of 3x3x8 ft concrete structures that can weigh about 6 tons. Dimensions placement could vary. These would simply be placed along the top of each unit, and, although expensive to fabricate, it might be cheaper than adding and constructing additional armor layers. More sand will be required for the system as well. The shore planform can only adjust vertically with SLR unless the system is moved offshore. Moving the breakwaters offshore and adding much more sand might be cost prohibitive as the breakwater rock volume would increase and additional rock would be required. The high value of infrastructure behind Yorktown Beach as well as the economic value of beach usage make maintaining the beach important.

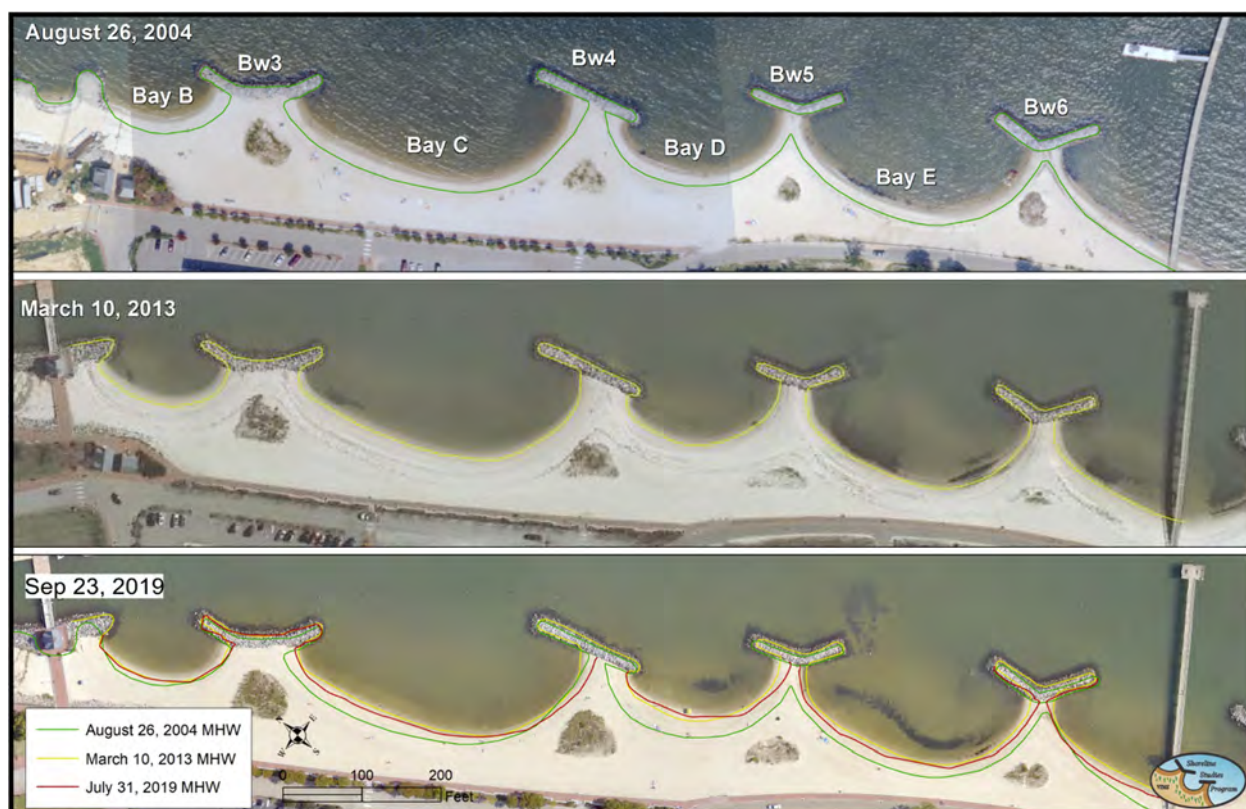
Figure 4-2-5. Shoreline change between 2004 and 2019 at the Yorktown breakwaters. The 2004 and 2013 shorelines are approximately mean high water based on the digitizer's best guess of the features shown on the aerial photo. The 2019 shoreline is from the survey data.

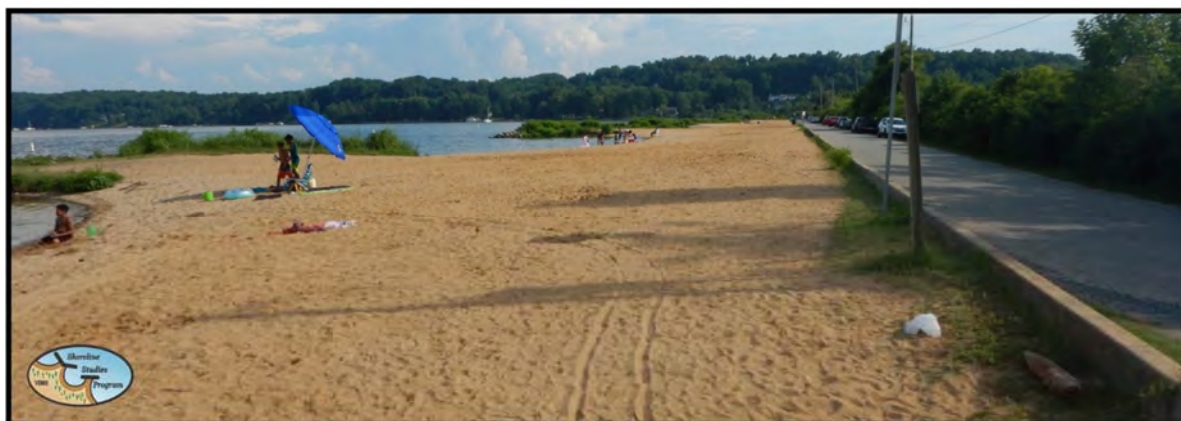
Figure 4-3-4. A wide recreational beach exists at Aquia Landing shoreline on 16 Jul 2019.

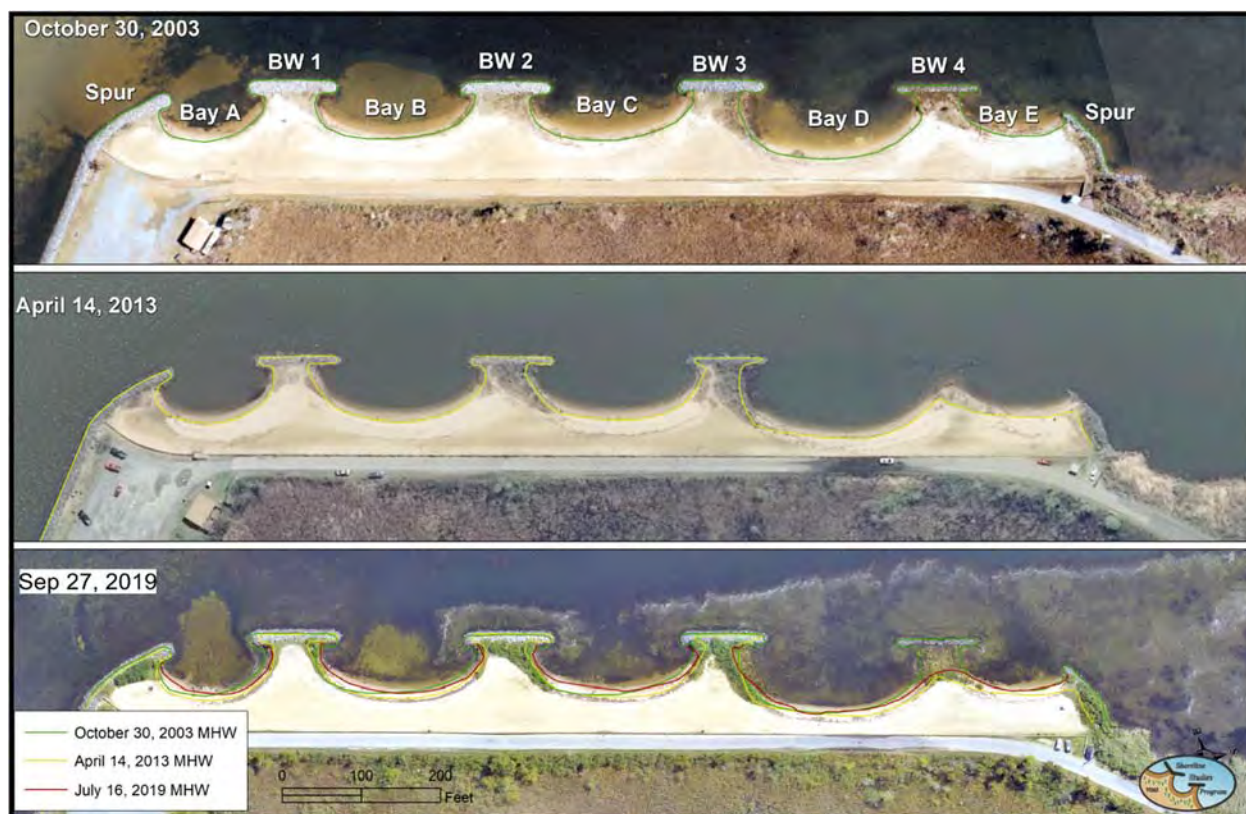
Figure 4-3-5. Shoreline change between 2003 and 2019 at the Yorktown breakwaters. The 2003 and 2013 shorelines are approximately mean high water based on the digitizer's best guess of the features shown on the aerial photo. The 2019 shoreline is from the survey data.

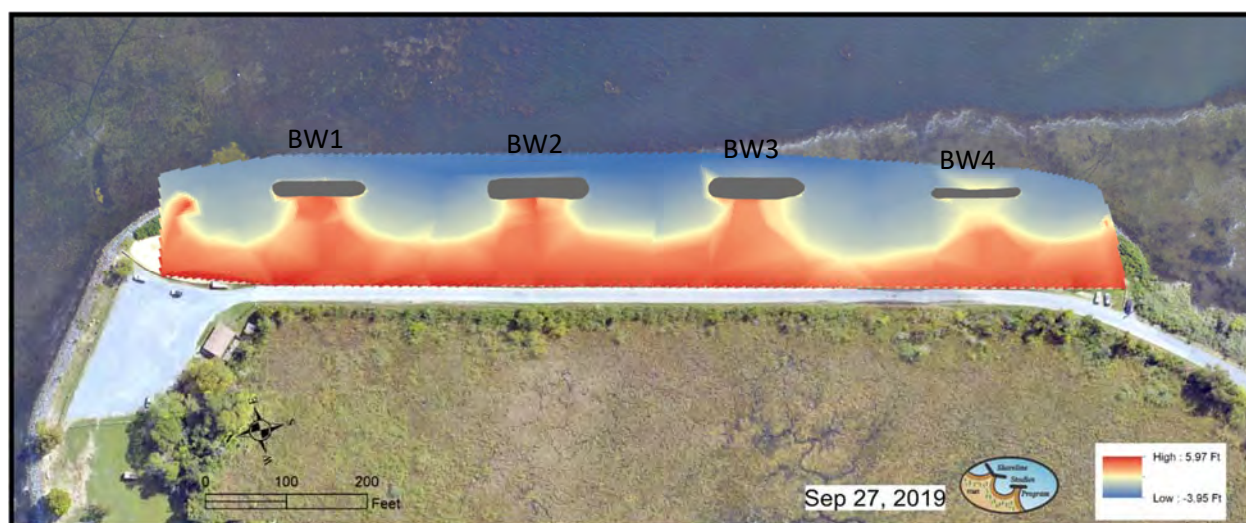
Though the storm surge topped the system during Hurricane Isabel and sand washed over the jersey wall onto the road (Figure 4-3-3), no extreme changes in topography were measured indicating that overall, the breakwater system remained stable during the storm (Hardaway *et al.*, 2006). The beach along Aquia Landing has been relatively unchanged since Hurricane Isabel. The shore planform has remained relatively stable since Isabel except for the thinning of tombolo attachments which have not impacted the beach and backshore (Figure 4-3-4). A wide recreational beach occurs at the site. The tombolos are heavily vegetated and a great deal of SAV occurs in the nearshore. Some variation has occurred in the position of MHW over time (Figure 4-3-5), but it has been relatively minor. The position of the embayments post-Hurricane Isabel shoreline on October 30, 2003, were slightly shifted due to wind and wave action during the storm. The 2013 and 2019 high water shorelines are similar although the 2019 tends to be riverward of the 2013. The tombolo at breakwater 4 has lost its attachment over time as the structure itself sank. Though heavily vegetated, the breakwater 4 tombolo is lower than the others (4-3-6).

Figure 4-3-6. Digital elevation model of the collected survey points at Aquia Landing.

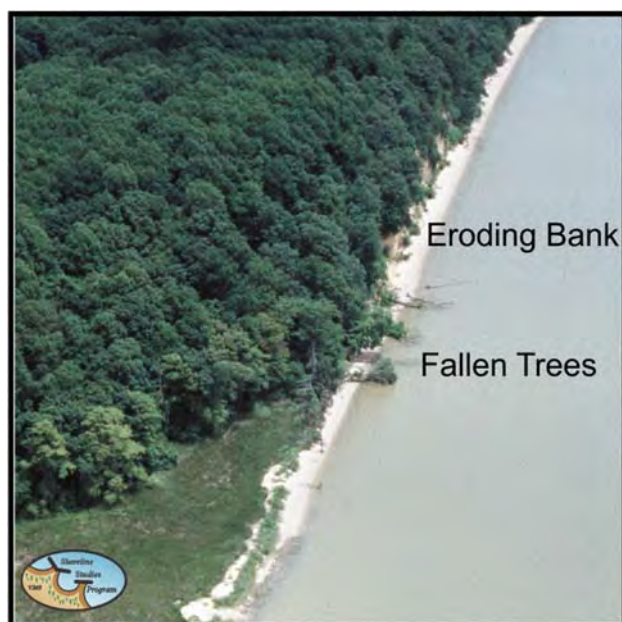
Kingsmill is located on the north shore of the James River in James City County, Virginia (Figure 4-4-1). It is a privately owned site that had chronic bank erosion and has a long fetch exposure to the south of over 12 miles and the southwest of over 5 miles (Figure 4-4-2). Wind frequencies from these directions are about the same, and the site occurs in what is considered a bimodal wind/wave setting. The developer of the upscale residential community wanted shore erosion control with environmental edge so a 2,800 ft breakwater system was installed in 1996. It consisted of six headland breakwaters ranging in size from 115 ft to 210 ft, a 110 ft low breakwater and a 170 ft revetment for boundary interfacing structures, beach fill, and wetlands plantings, all of which were designed for a 50-yr storm event. The site's seventy-foot-high banks had little sand and posed potential upland drainage problems. The design routed upland drainage to an adjacent marsh, and low swales in the bank were used to allow storm water to diffuse through a vegetated beach fill. Beach fill was obtained from an upland borrow pit. The overall purpose of the project was to provide shore protection and habitat enhancement.

Figure 4-4-2. Kingsmill shoreline June 1996 prior to breakwater installation.

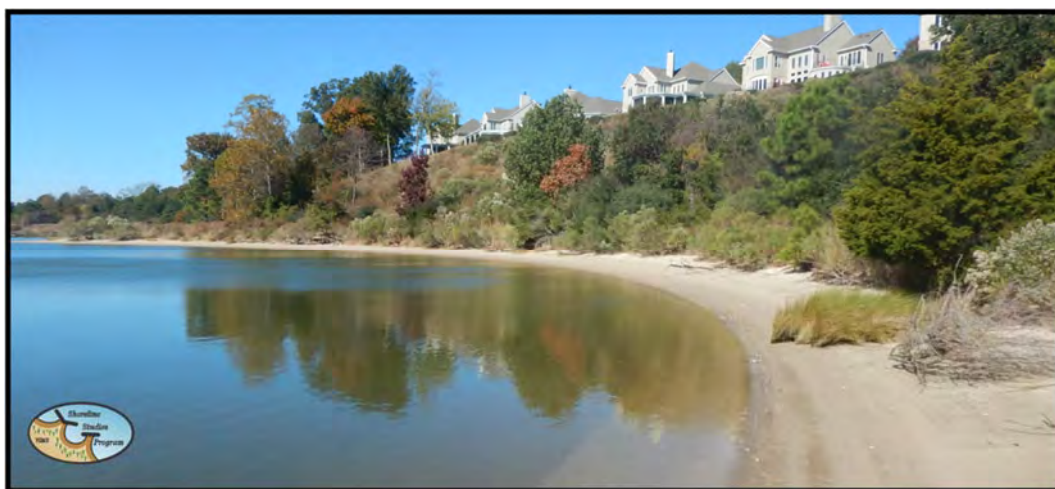
The shoreline is similar today with heavily vegetated tombolos and backshore and stable embayments (Figure 4-4-3). Post Hurricane Isabel, the tombolo attachment behind the breakwaters was lost (Figure 4-4-4). However, over time, sand accumulated behind the structures, particularly breakwaters 3 and 4, and became vegetated. Breakwaters 5 and 6 are still subaerially attached

Figure 4-4-3. Stable embayment along the Kingsmill shoreline in 2019.

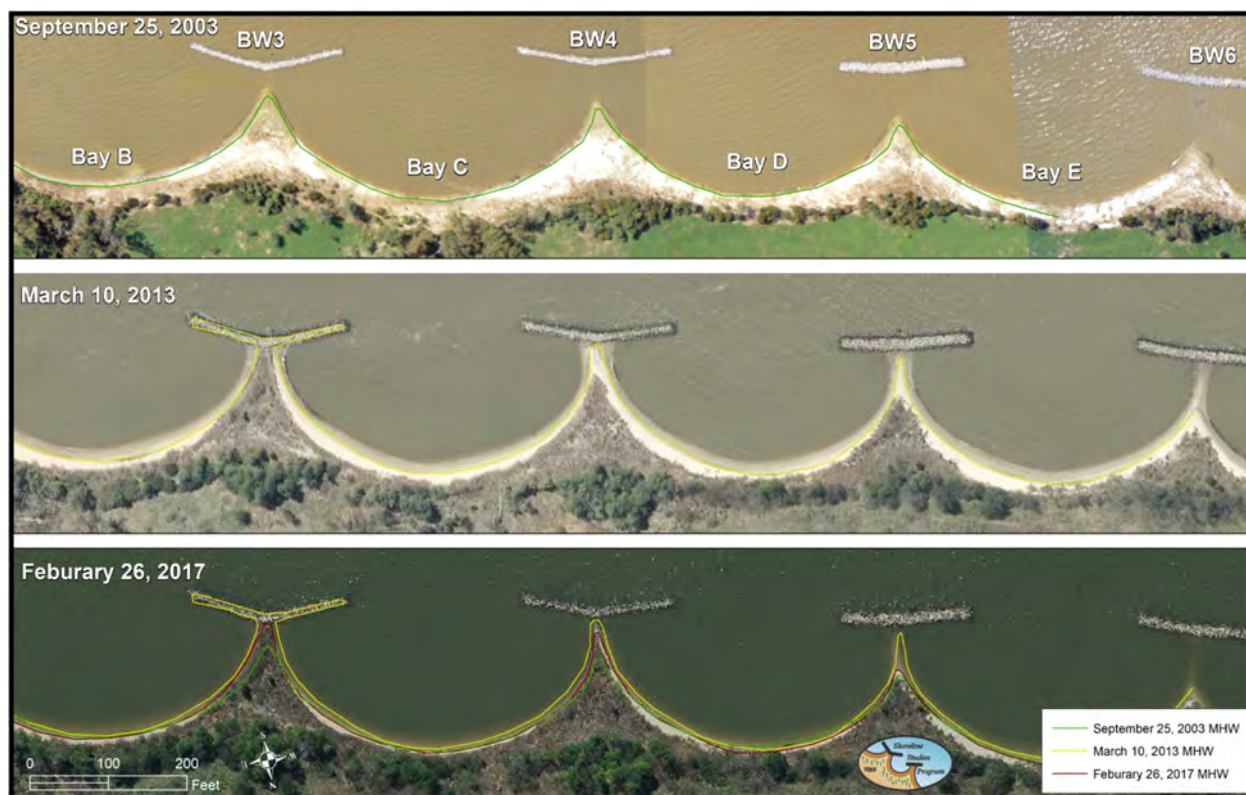
Figure 4-4-4. Shoreline change between 2003 and 2017 at the Yorktown breakwaters. The shorelines are approximately mean high water based on the digitizer's best guess of the features shown on the aerial photo.

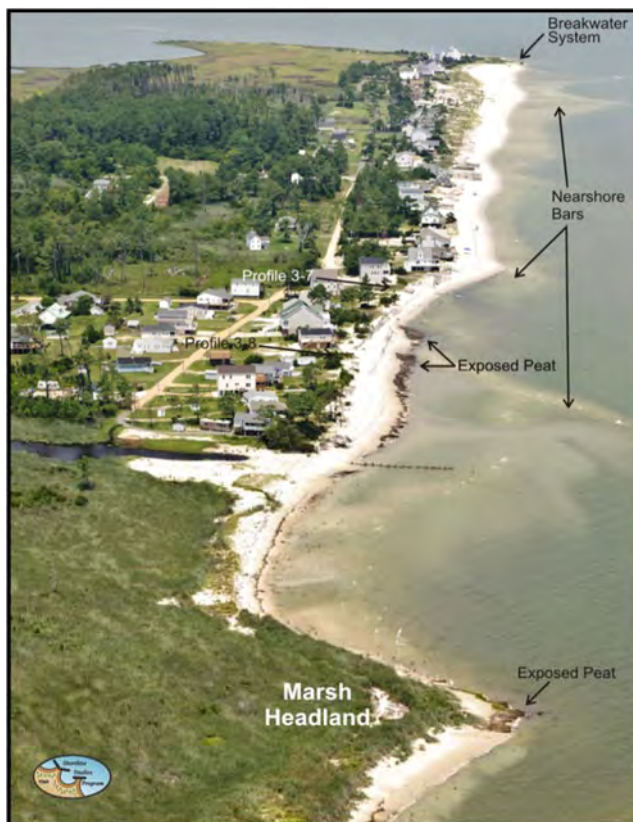
Figure 4-5-2. A 2011 aerial photo of MA3 depicting morphologic features (from Milligan et al., 2013). The breakwaters shown are on the northern end of the system and are not the ones studied for this project. They occur at the southern end near where the exposed peat is shown in front of the houses.

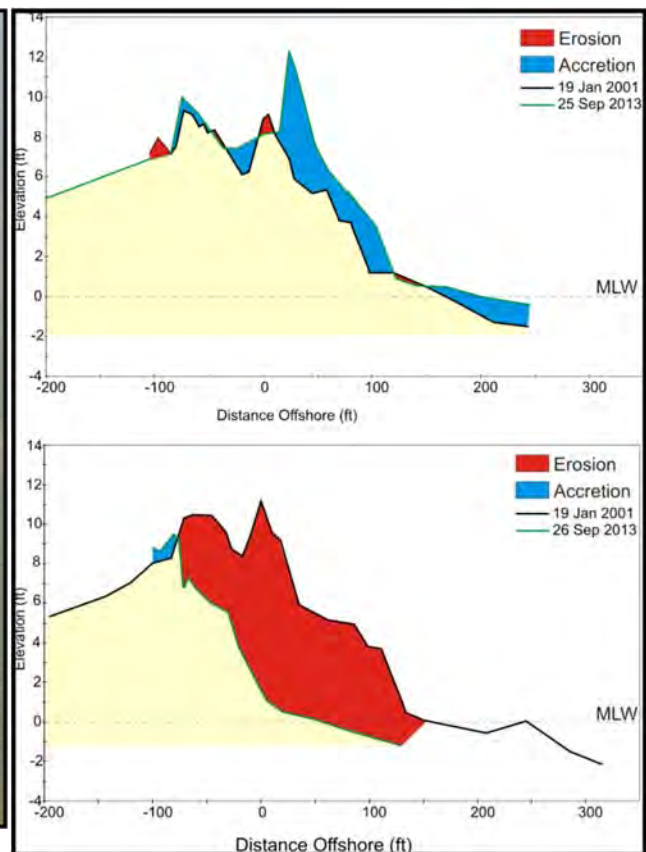
The Chesapeake Shores/Bavon Beach shore reach was significantly impacted by storms since monitoring began including those listed in Section 1.3 as well as Hurricane Sandy in October 2012 (Figure 4-5-3). The beach and dune system along the north half of the reach remained fairly well intact between 2001 and 2013 (Figure 4-5-3, top). The southern reach was particularly impacted as eroded beach sands were driven south with very little returning via northerly alongshore transport. As a result, several revetments were constructed along the subreach to protect houses exposed on the shoreline (Figure 4-5-4). Finally, in 2016, the breakwater system was constructed and consisted of 3 breakwaters with significant sand nourishment. Though the system has not weathered significant storms, overall, it has maintained its system integrity by maintaining tombolo attachment (Figure 4-5-5).

Figure 4-5-3. Depiction of the net change between 2001 and 2013 along the northern end (top) and southern end (bottom) of Ma3 (from Milligan et al., 2013). The southern end is where the breakwaters were constructed.

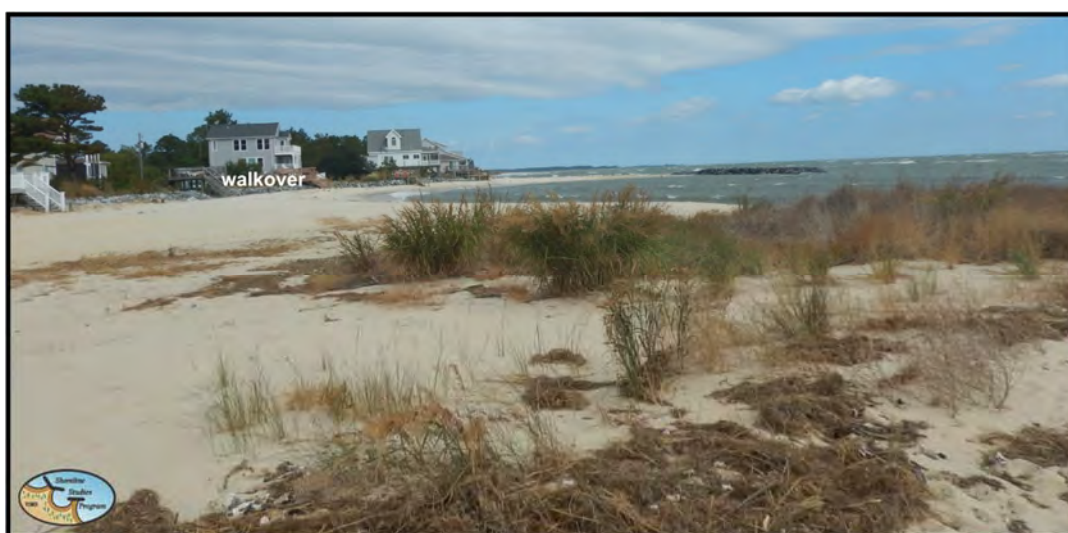
Figure 4-5-5. The beach is wide and the tombolo attached and vegetated along Bavon's shoreline in 2019.
